N11HDE Series Bronze Rotary Gear Pumps

OBN11HDME with clutch

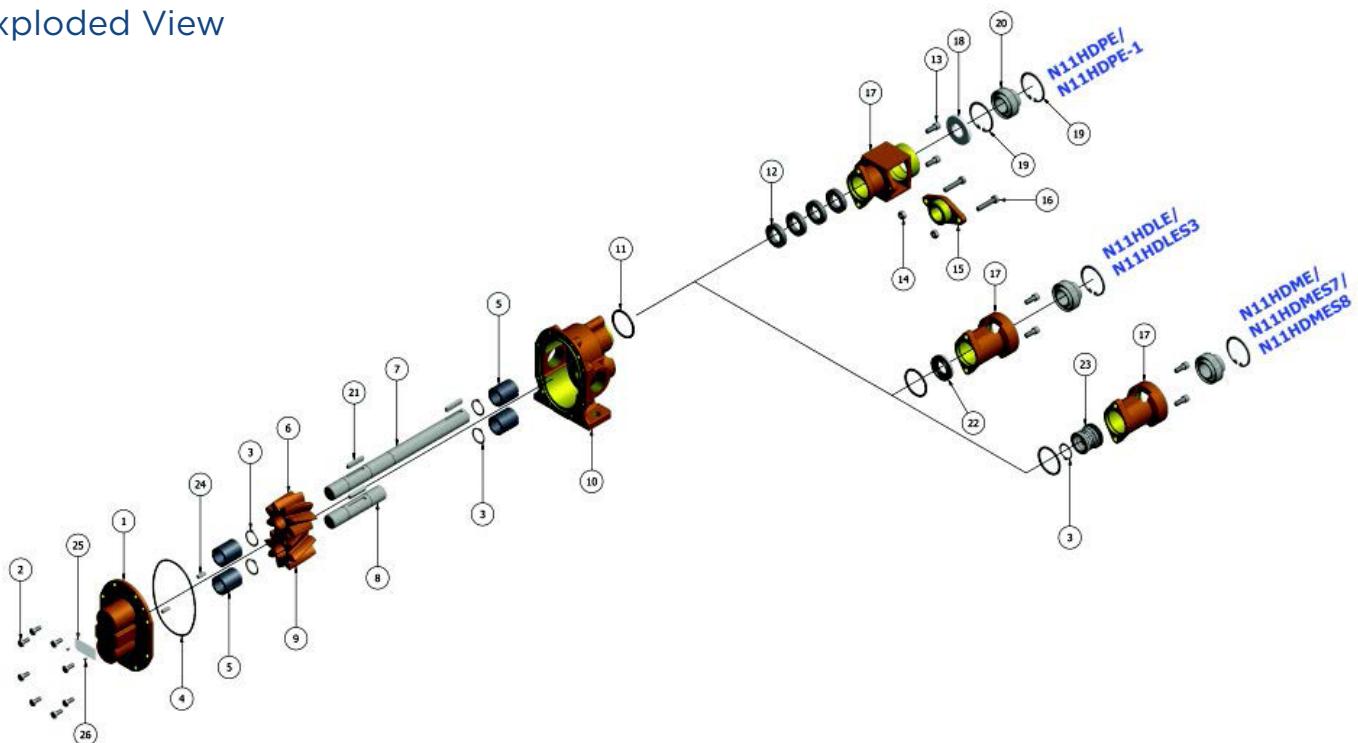
Exploded View

1	2	3	4	5	6	7	8	9	10	11	12	13
	Cover	Screw	Snap Ring	O-Ring	Bearing	Drive Gear	Drive Shaft	Idle Shaft	Idle Gear	Body	O-Ring	Packing Ring	Screw
Model	Qty. 1	Qty. 8	Qty.4/5	Qty. 1	Qty. 4	Qty. 1	Qty. 1	Qty. 1	Qty. 1	Qty. 1	Qty. 1	Qty. 4	Qty. 2
OBN11HDPE	OB9333NN5N	OB5393	OB7651 (4 Req'd)	OB9797-158	OB5108	OB9833	OB7366	OB7652	OB9834	OB9331NG7N	OB6515	OB7624	OB6827
OBN11HDLE	OB9333NN5N	OB5393	OB7651 (4 Req'd)	OB9797-158	OB5108	OB9833	OB7366	OB7652	OB9834	OB9331NG7N	OB9797-224	N/A	OB6827
OBN11HDLES3	OB9333NN5N	OB5393	OB7651 (4 Req'd)	OB9797-158	OB5108	OB9833	OB7366	OB7652	OB9834	OB9331NG7N	OB6515	N/A	OB6827
OBN11HDME	OB9333NN5N	OB5393	OB7651 (5 Req'd)	OB9797-158	OB5108	OB9833	OB7366	OB7652	OB9855	OB9331NG7N	OB6515	N/A	OB6827
OBN11HDME-06													
OBN11HDMES7	OB9333NN5N	OB5393	OB7651 (5 Req'd)	OB9797-158	OB5108	OB9833	OB7366	OB7652	OB9834	OB9331NG7N	OB9797-224	N/A	OB6827
OBN11HDMES8	OB9333NN5N	OB5393	OB7651 (5 Req'd)	OB9999-158	OB5108	OB9833	OB7366	OB7652	OB9834	OB9331NG7N	OB6515	N/A	OB6827

14	15	16	17	18	19	20	21	22	23	24	25	26	Repair Kit
	Nut	Gland	Screw	Seal Ho-using	Lip Seal	Snap Ring	Ball Bearing	Key	Lip Seal	Seal Assy	Dowel Pin	Tag	Tag Screw	
Model	Qty. 2	Qty. 1	Qty. 2	Qty. 1	Qty. 1	Qty. 1/2	Qty. 1	Qty. 3	Qty. 1	Qty. 1	Qty. 2	Qty. 1	Qty. 2	
OBN11HDPE	OB8395	OB7451	OB9905	OB7449	OB6710	OB7372 (2 Req'd)	OB7368	OB6518	N/A	N/A	OB8597	OB9344	OB9345	OB11003
OBN11HDLE	N/A	N/A	N/A	OB7365	N/A	OB7372 (1 Req'd)	OB7368	OB6518	OB7262	N/A	OB8597	OB9344	OB9345	OB11005
OBN11HDLES3	N/A	N/A	N/A	OB7365	N/A	OB7372 (1 Req'd)	OB7368	OB6518	OB6500	N/A	OB8597	OB9344	OB9345	OB11006
OBN11HDME	N/A	N/A	N/A	OB7365	N/A	OB7372 (1 Req'd)	OB7368	OB6518	N/A	OB32315	OB8597	OB9344	OB9345	OB11007
OBN11HDME-06														
OBN11HDMES7	N/A	N/A	N/A	OB7365	N/A	OB7372 (1 Req'd)	OB7368	OB6518	N/A	OB32372	OB8597	OB9344	OB9345	OB11008
OBN11HDMES8	N/A	N/A	N/A	OB7365	N/A	OB7372 (1 Req'd)	OB7368	OB6518	N/A	OB33335	OB8597	OB9344	OB9345	TBD

Repair Kit contain items 3, 4, 5, 6, 7, 8, 9, 11, 12, 18, 22 & 23

Seal conversion kits illustrated (on back) are designed for quick removal and replacement. In each case, seal housings are fastened to pump bodies by means of 2 bolts, item 13.

IMPORTANT: Before attempting to remove a seal housing containing seal components by sliding them off the pump shaft, be sure to unlock 2 set screws locking the ball bearing inner race to the pump shaft. The ball bearing is identified as item 20. Also, before attempting to slide the seal housing from the pump shaft, remove all burrs, scale, and projections that could be formed by fretting corrosion.
