OBERDORFER[®]

N13HD Series Bronze Pedestal Rotary Gear Pumps

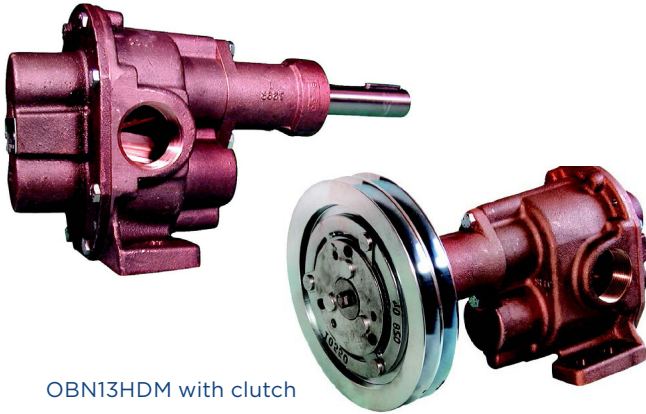
OBN13HDM with clutch

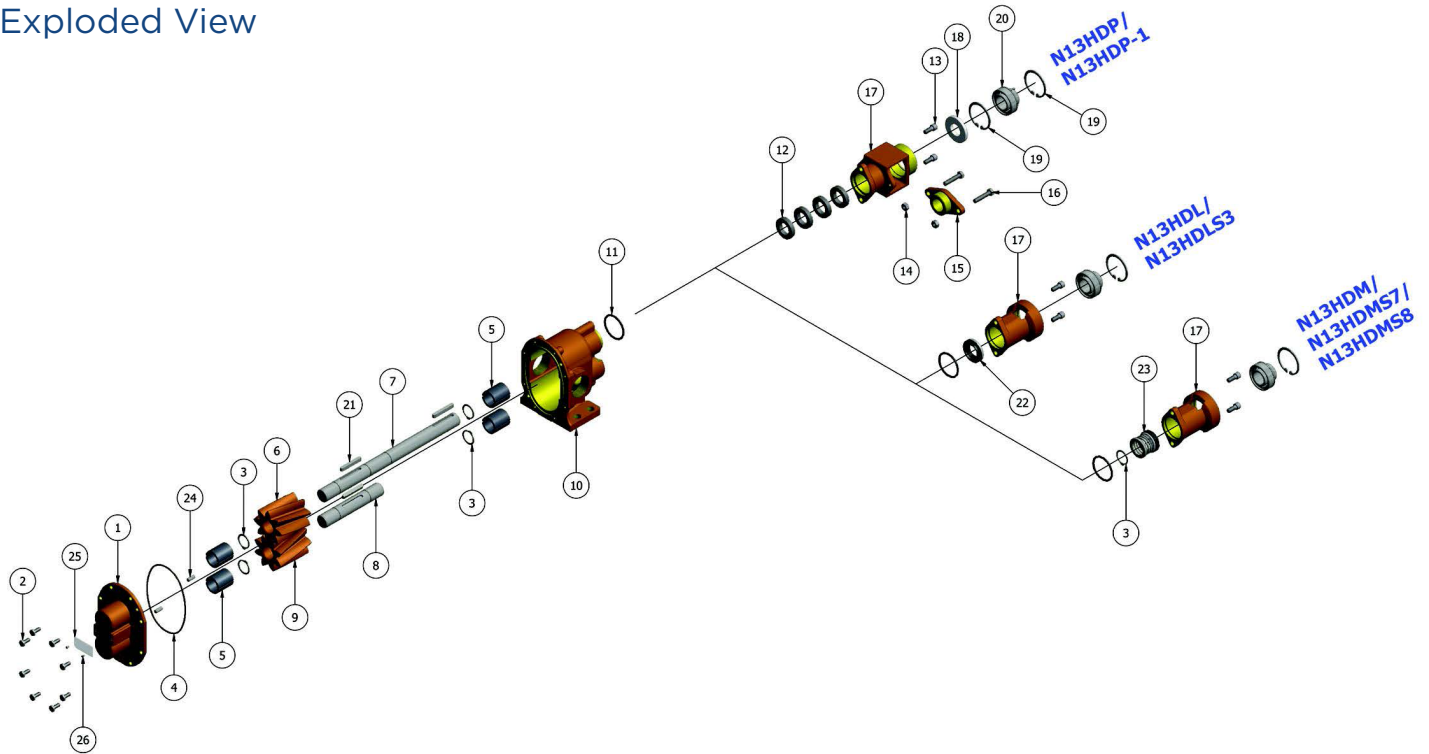
Exploded View

1	2	3	4	5	6	7	8	9	10	11	12	13
	Cover	Screw	Snap Ring	O-Ring	Bearing	Drive Gear	Drive Shaft	Idle Shaft	Idle Gear	Body	O-Ring	Packing Ring	Screw
Model	Qty. 1	Qty.8	Qty.4/5	Qty. 1	Qty. 4	Qty. 1	Qty. 1	Qty. 1	Qty. 1	Qty. 1	Qty. 1	Qty. 4	Qty. 2
OBNI3HDP	OB9333NN5N	OB5393	OB7651 (4 Req'd)	OB9797-158	OB5108	OB9854	OB7570	OB7653	OB9855	OB9332NH7N	OB6515	OB7624	OB6827
OBNI3HDL	OB9333NN5N	OB5393	OB7651 (4 Req'd)	OB9797-158	OB5108	OB9854	OB7570	OB7653	OB9855	OB9332NH7N	OB9797-224	N/A	OB6827
OBNI3HDLS3	OB9333NN5N	OB5393	OB7651 (4 Req'd)	OB9797-158	OB5108	OB9854	OB7570	OB7653	OB9855	OB9332NH7N	OB6515	N/A	OB6827
OBNI3HDM	OB9333NN5N	OB5393	OB7651 (5 Req'd)	OB9797-158	OB5108	OB9854	OB7570	OB7653	OB9855	OB9332NH7N	OB6515	N/A	OB6827
OBNI3HDM-O6													
OBNI3HDS7	OB9333NN5N	OB5393	OB7651 (5 Req'd)	OB9797-158	OB5108	OB9854	OB7570	OB7653	OB9855	OB9332NH7N	OB9797-224	N/A	OB6827
OBNI3HDS8	OB9333NN5N	OB5393	OB7651 (5 Req'd)	OB9999-158	OB5108	OB9854	OB7570	OB7653	OB9855	OB9332NH7N	OB6515	N/A	OB6827

14	15	16	17	18	19	20	21	22	23	24	25	26	Repair Kit
	Nut	Gland	Screw	Seal Housing	Lip Seal	Snap Ring	Ball Bearing	Key	Lip Seal	Seal Assy	Dowel Pin	Tag	Tag Screw	
Model	Qty. 2	Qty. 1	Qty. 2	Qty. 1	Qty. 1	Qty. 1/2	Qty. 1	Qty. 3	Qty. 1	Qty. 1	Qty. 2	Qty. 1	Qty. 2	
OBNI3HDP	OB8395	OB7451	OB9905	OB7449	OB6710	OB7372 (2 Req'd)	OB7368	OB6518	N/A	N/A	OB8597	OB9344	OB9345	OB11009
OBNI3HDL	N/A	N/A	N/A	OB7365	N/A	OB7372 (1 Req'd)	OB7368	OB6518	OB7262	N/A	OB8597	OB9344	OB9345	OB11011
OBNI3HDLS3	N/A	N/A	N/A	OB7365	N/A	OB7372 (1 Req'd)	OB7368	OB6518	OB6500	N/A	OB8597	OB9344	OB9345	OB11012
OBNI3HDM	N/A	N/A	N/A	OB7365	N/A	OB7372 (1 Req'd)	OB7368	OB6518	N/A	OB32315	OB8597	OB9344	OB9345	OB11013
OBNI3HDM-O6														
OBNI3HDS7	N/A	N/A	N/A	OB7365	N/A	OB7372 (1 Req'd)	OB7368	OB6518	N/A	OB32372	OB8597	OB9344	OB9345	OB11014
OBNI3HDS8	N/A	N/A	N/A	OB7365	N/A	OB7372 (1 Req'd)	OB7368	OB6518	N/A	OB33335	OB8597	OB9344	OB9345	TBD

Repair kit contain items 3, 4, 5, 6, 7, 8, 9, 11, 12, 18, 22 & 23

Seal conversion kits illustrated (on back) are designed for quick removal and replacement. In each case, seal housings are fastened to pump bodies by means of 2 bolts, item 13.

IMPORTANT: Before attempting to remove a seal housing containing seal components by sliding them off the pump shaft, be sure to unlock 2 set screws locking the ball bearing inner race to the pump shaft. The ball bearing is identified as item 20. Also, before attempting to slide the seal housing from the pump shaft, remove all burrs, scale, and projections that could be formed by fretting corrosion.
